# Earth Investigations Consultants

October 5, 2005  
Job 1663.01.01

**RE: SUPPLEMENTAL GEOTECHNICAL PEER REVIEW**  
Slope Stability  
Proposed Forest Green Estates, Tract 8268  
Richmond, California

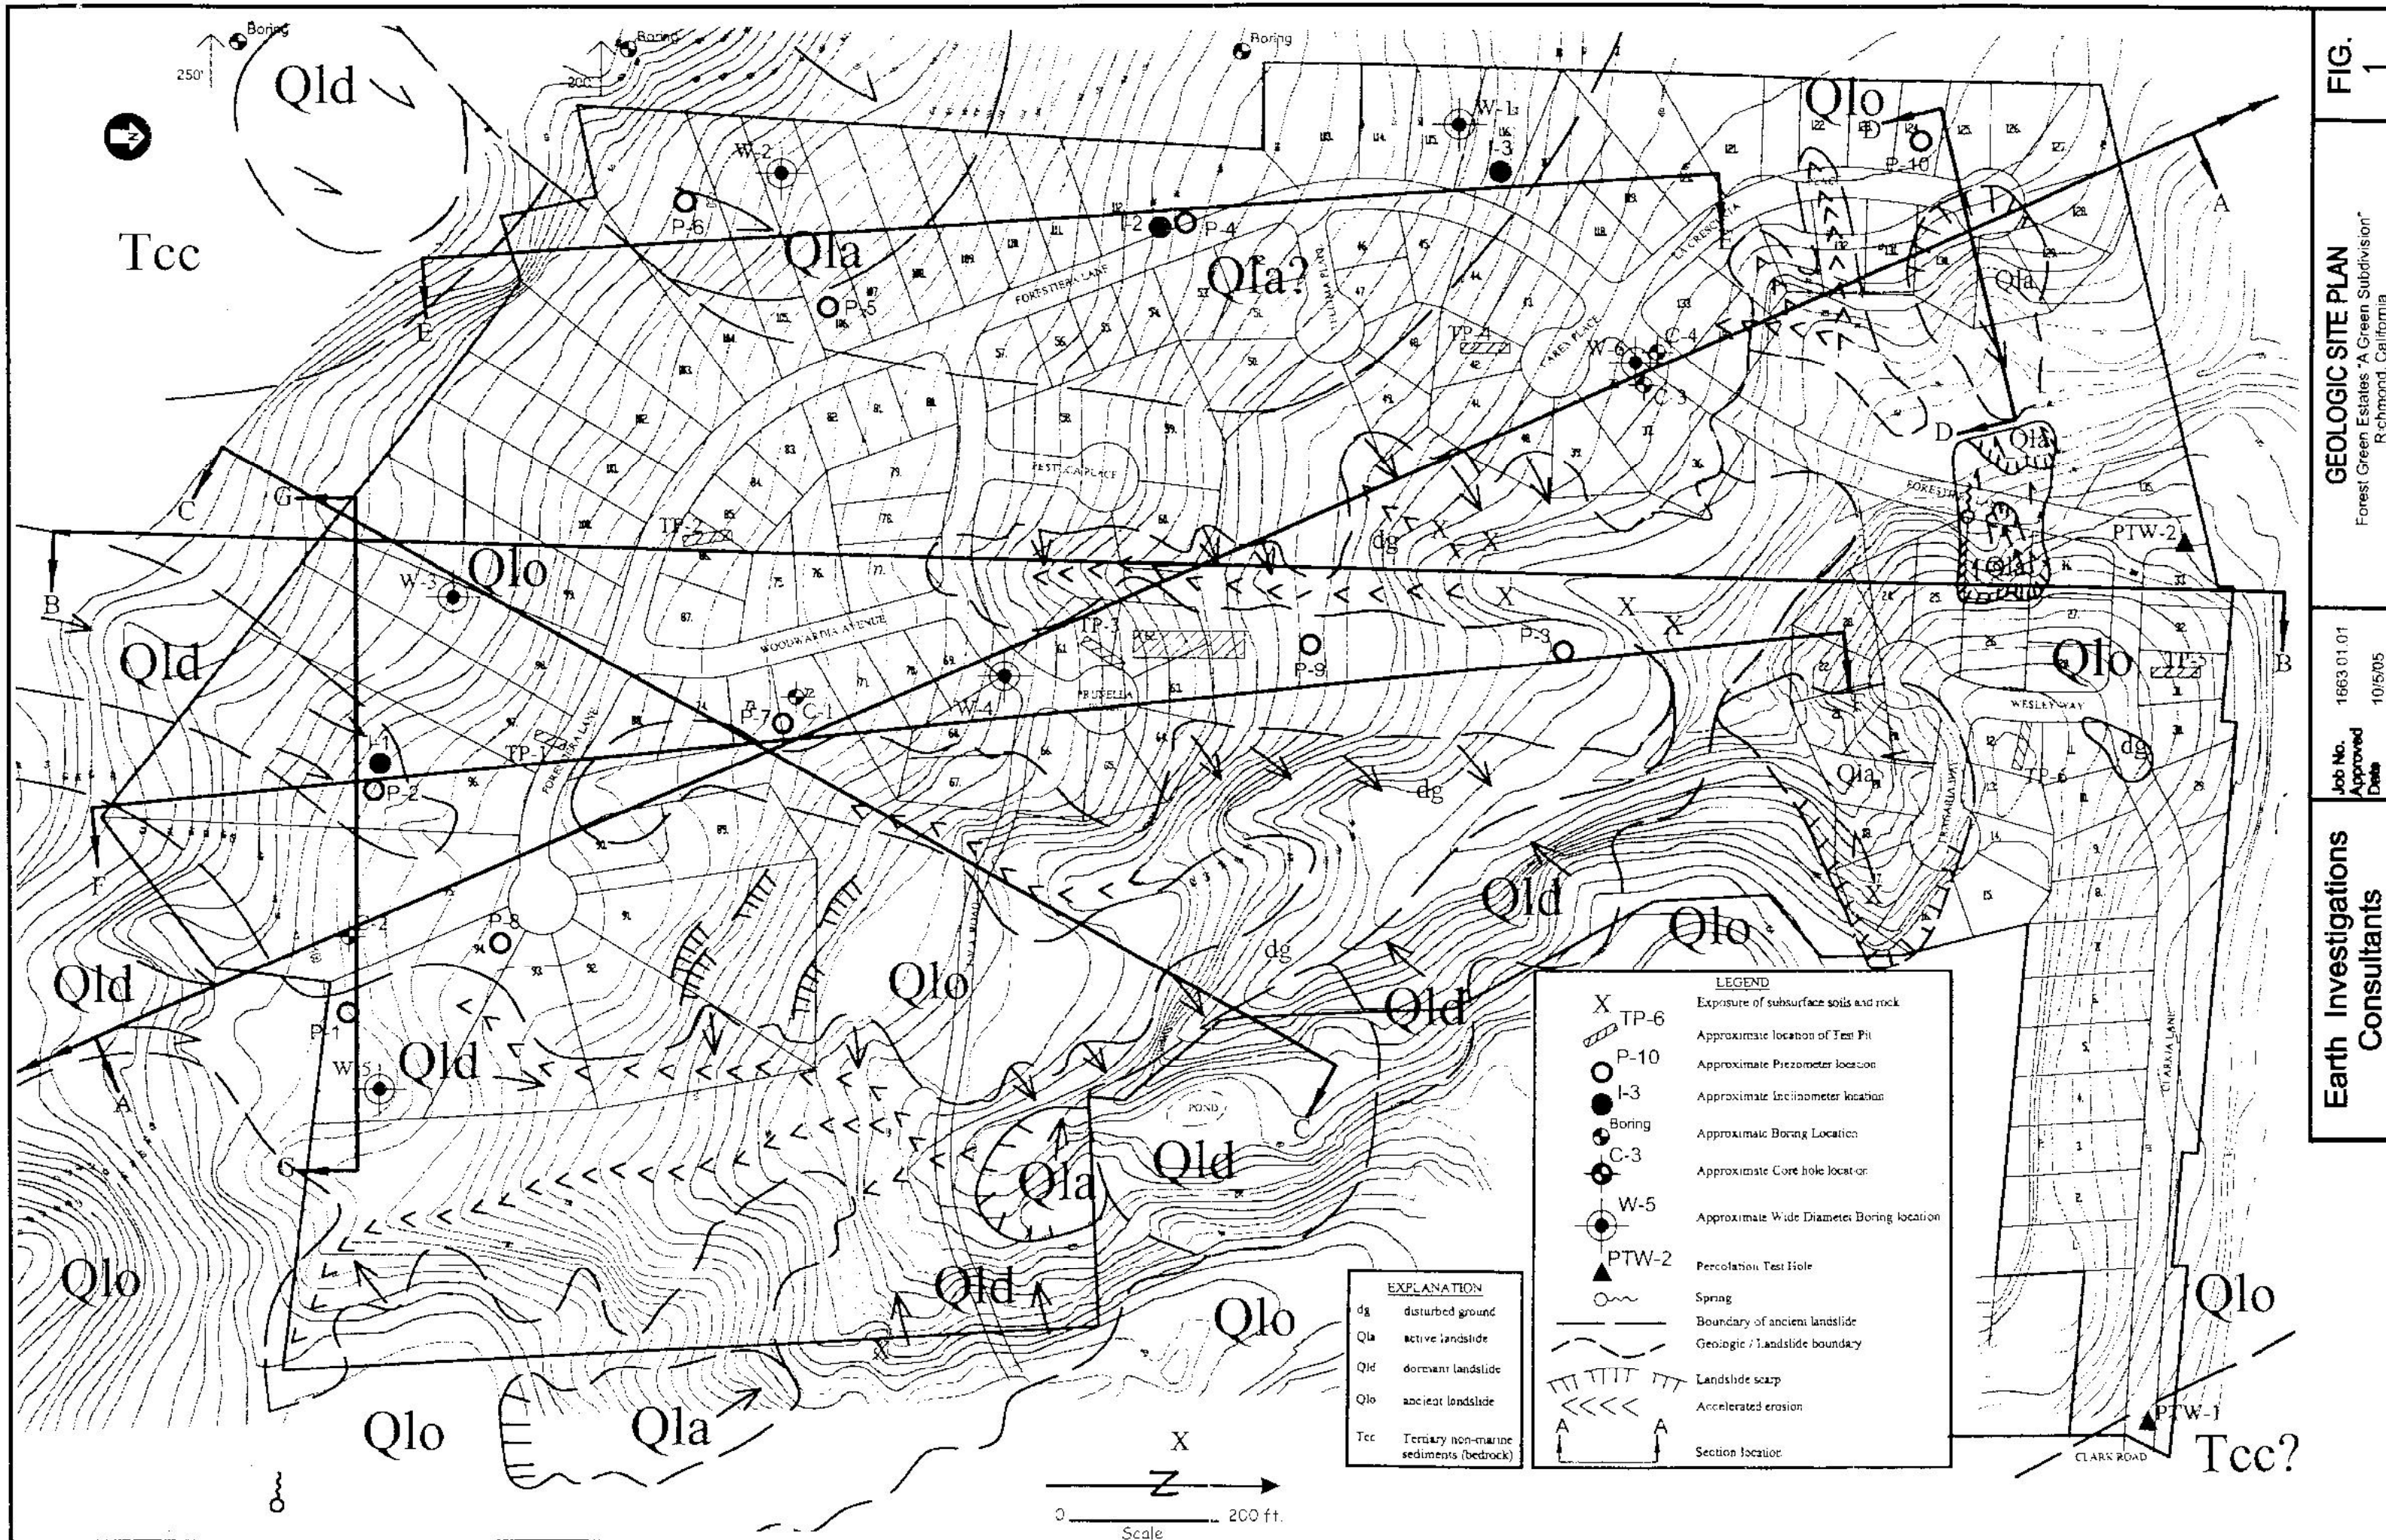
For additional stability across the western and south-central parts of the site, a 40-foot deep buttress is recommended (Figure 1), however, justification for the distribution and depth of buttressing is unclear. The distribution will be constrained by site boundaries and sensitive habitats. In an analysis of the walls of the buttress excavation, TI concludes a temporary 1H:1V slope is unstable, requiring excavation in 75-foot sections below a depth of 20 feet. The upper 20 feet can be mass graded.

To further assess active landsliding encroaching onto the western part of the site, TI drilled 3 borings on the adjacent Park Property (Figure 1; logs of borings not included in submittal). They conclude the borings confirm the presence of a large creeping landslide to depths of 60 to 65 feet, and of a smaller active landslide to a depth of 48 feet. Ground water was encountered at depths ranging from 25 to 40 feet, with perched water at 15 feet. Slope inclinometer data to confirm interpretation of landsliding and creep depths from the borings was not presented.

- We judge the evaluation of ground water elevations across the site reasonable. However, there are a few items that remain unknown:
  - Will it be acceptable to extend the hydraugers offsite as illustrated on Figure 1?

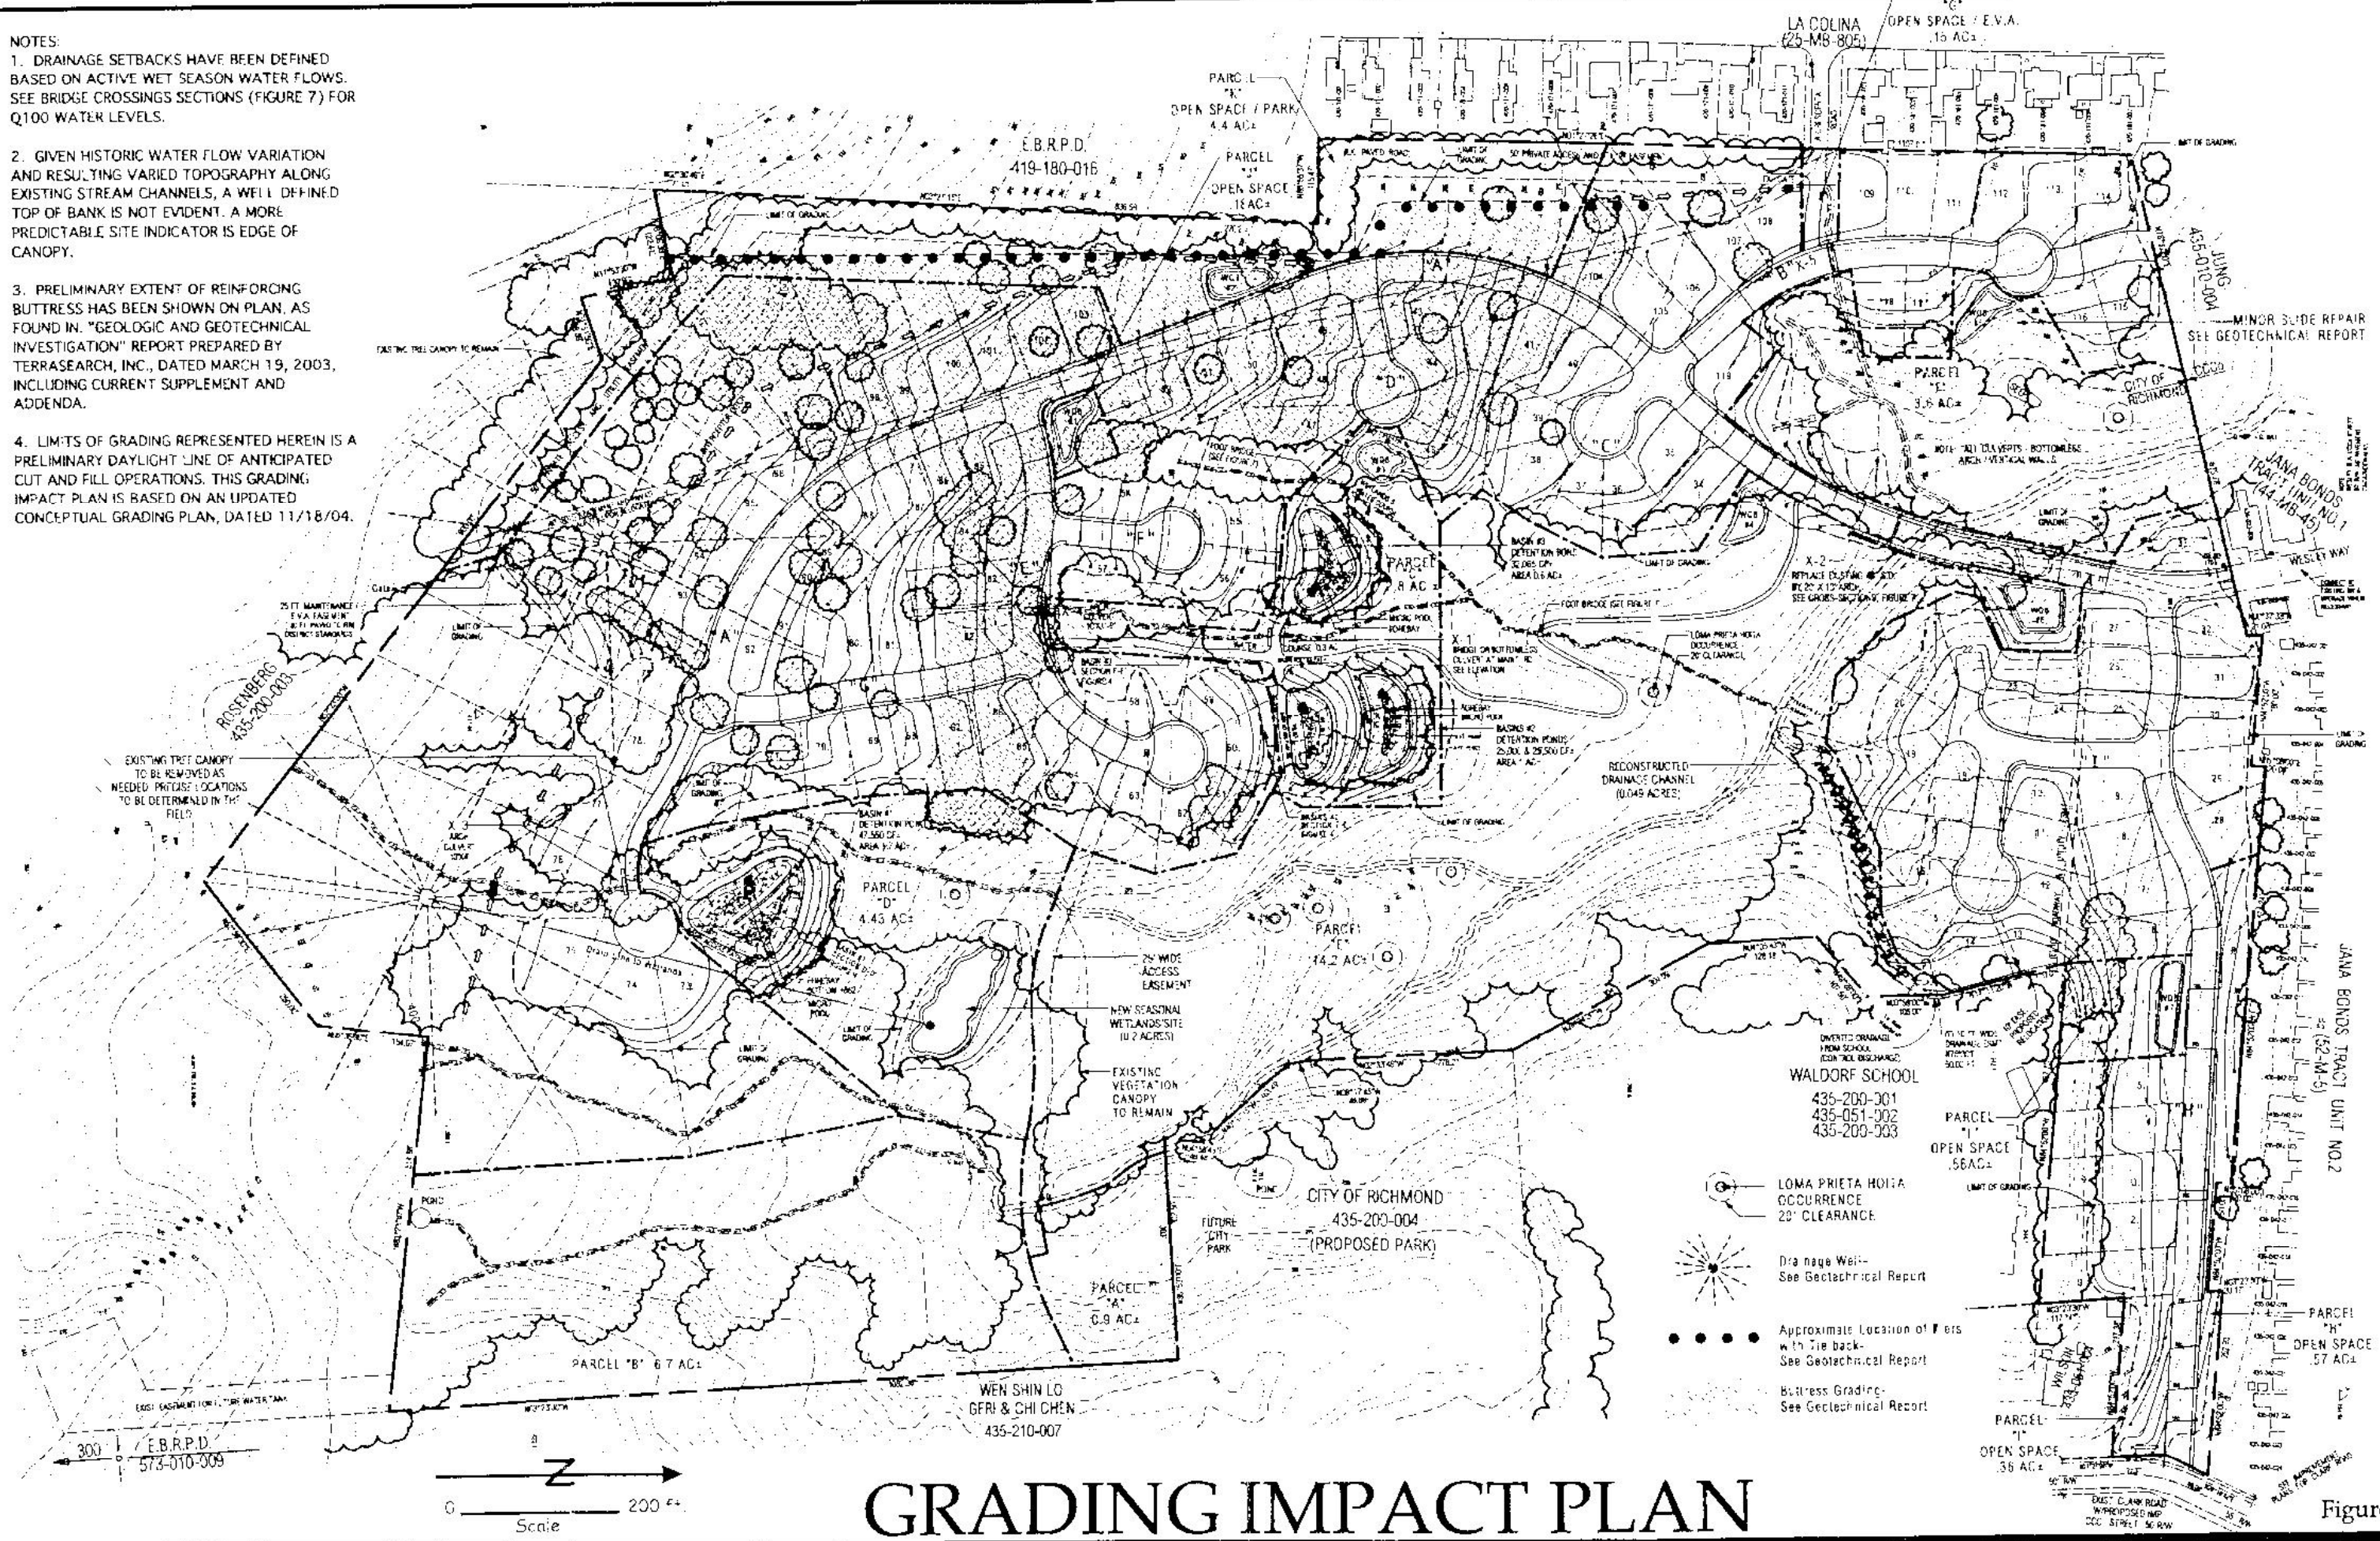
FIG. 2

Given the potential impact to site stability, TI recommends control of ground water by a scheme presented by Drilltech Drilling and Shoring (2005). The creative ground water withdrawal system involves drilling 2, 25- to 30-foot diameter shafts to a depth of 120 feet in the southern part of the site (Figure 2). A series of 300-foot long, horizontal drains (hydraugers) will be arranged in a radial pattern from varying elevations of each shaft wall to intercept ground water. The shaft will be designed as a sump to collect the water from the hydraugers. Accumulated water would either be pumped to a storm drainage facility, such as a seasonal wetland, or drained by gravity to an onsite swale, which, given the terrain would probably be in the middle of the site.
